Wind Turbine Operation Analysis under an Extreme Turbulence Wind Condition in Taiwan

Abstract—Wind turbulence intensity can substantially affect the operation of a wind turbine. According to IEC design requirements, a wind turbine must withstand wind of class “xA” intensity, during which wind speed may change within seconds. These conditions can cause excessive fatigue on the system and substantially degrade operating performance. This study compared wind turbine operating performance between high and low wind turbulence conditions. The Taiwan data show that wind conditions are much more inconsistent than in other countries. Therefore, turbines imported from Europe must be modified to suit the Taiwan environment.

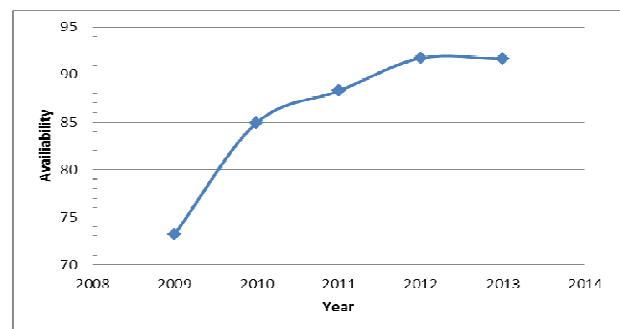
Fig.1:Example of availability in local wind farm[1]

A well-operated wind farm should have an availability higher than 95%. This percentage is considered reasonable in the global onshore wind market. After the commission and operation of wind farms in Taiwan, however, operators experienced operational problems that have not been encountered by wind farms in other countries. These phenomena have resulted in very low operation availability of the wind farms. Figure 1 shows the data for one local operator. Availability was only 73.21% in 2009 and then increased to 91.6% in 2013[1]. OR Although availability is improving annually, it is still far below the market average.

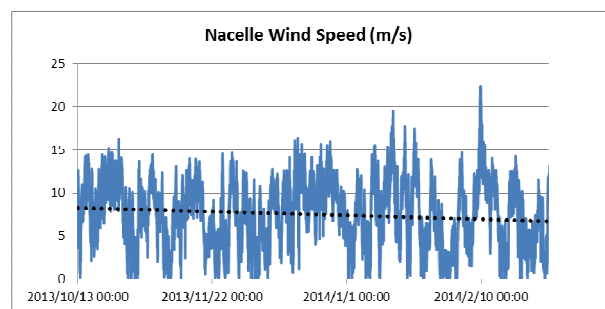
Fig.3: Average wind speed measured at nacelle

This study collected operational data for the designated Z72 wind farm from October, 2013 to October, 2014. The effective data show an average wind speed of only 6.19m/s during this year and an average turbulence intensity 0.17 higher than the standard. (The turbulence intensity was calculated from the average wind speed data higher than 12m/s to emphasis the effect of the pitch action). Figures 3-4 show the wind speed and turbulence intensity data, respectively. The dotted lines in these two figures are the show the average wind speed and turbulence.

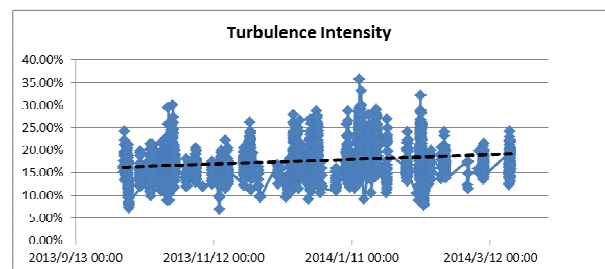
Fig.4: Turbulence Intensity of the site at nacelle

The statistical data indicate that high wind turbulence is common at this site. Therefore, fatigue caused by excessive load on the turbine may be a safety issue. Maintaining good performance of the pitch system is also challenging under the extremely turbulent wind conditions. This study found that the widely varying wind speed can cause an overspeed trip in this turbine. The pitch system may be unable to respond to wide variations in wind speed.

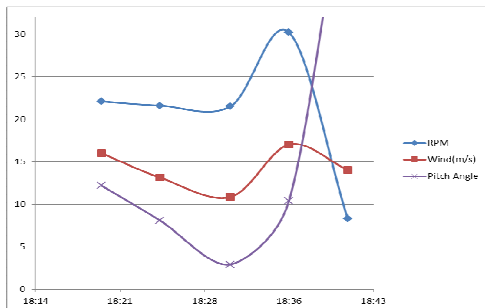
Fig.5: Response to wind turbulence

This study analyzed of the effects of extremely turbulent wind conditions that occurred on October 4, 2014. Table 1 shows that the rotational speed of the turbine is 22.5 rpm. In Tab.3 below, at 18:20 (minute: second), the turbine runs with 22.1 rpm under wind speed 16.01. At 18:25, wind speed decreased to 13.14m/s. This also changed the pitch angle from 12.2 to 8.1 degrees, which increased wind power. AT 18:31, the wind speed further decreased, and the system changed the pitch to collect more wind energy. However, the next time stamp indicated that the wind speed changed to 17.02 m/s at 18:36. The data in the table clearly show that, when the rotor runs up to 30.2 rpm, the maximum rotational speed of the turbine approximates 26.0 rpm, which causes an emergency trip in the turbine. The turbine then quickly shuts down when

the pitch angle increases to 90 degrees. Figure 5 illustrates the above actions.

Table 4 also shows that the turbulence intensity in this short period is 0.228, which is much higher than the design value of 0.16. Therefore, if the original manufacturer did not consider this unique but common wind condition in the controller for the pitch system, the system would not operate efficiently in this situation. An overspeed trip would occur frequently in this turbine and in this site. When the wind speed decreases and then suddenly increases, the pitch system needs to stop in one direction then reverse operation to start pitching. Since these consecutive actions increase the time needed to change the pitch, rotational speed increases to an abnormal value.

The original manufacturer of the Z72 turbine no longer provides support. Therefore, original design information, including control logic and codes, are unavailable. Reverse engineering the codes and modeling all other subsystems would be very time consuming. Doing so would be the best way to redesign the system and to respond to the updated wind condition. However, the operator can make hardware changes to solve this problem quickly. For example, the output of the pitch drive can be examined to determine whether the maximum output can be increased by a fixed ratio to increase the speed of the pitching action. If not, the pitch drive can be replaced to fit the pitching requirement.
